# Load behaviors of a prefabricated wood framing house during lifting and transportation

**Abstract** Lifting for handling and flatbed truck transportation to the job site are important processes during manufacture of prefabricated wooden construction units like mini homes and building modules. Significant damage can occur to sections or components of units during these operations. Although damage usually will not impair its structural safety, it is costly to fix and causes the public to perceive prefabricated wooden buildings as low quality products. Field observations and preliminary numerical models for prefabricated units subject to lifting and transportation forces are summarized here. Once fully developed and verified, models will support the creation of damage mitigation strategies centered on structural details indicating how units are to be supported during lifting and transportation.

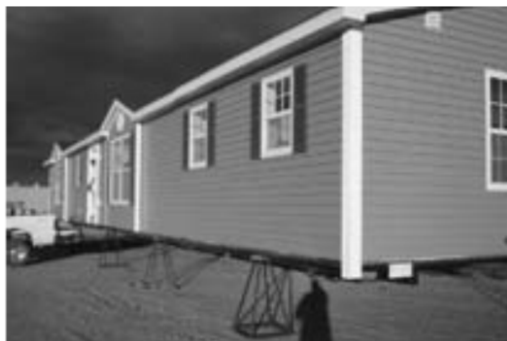
**Fig. 1** Tested mini home with dimensions of 4.88 m× 22.6 m

The mini home tested represents the longest and widest prefabricated unit allowed to be transported on public roads in North America (Fig. 1). Such units are of the type prone to damage during handling and transportation processes.

a. Plan view

b. Typical elevation

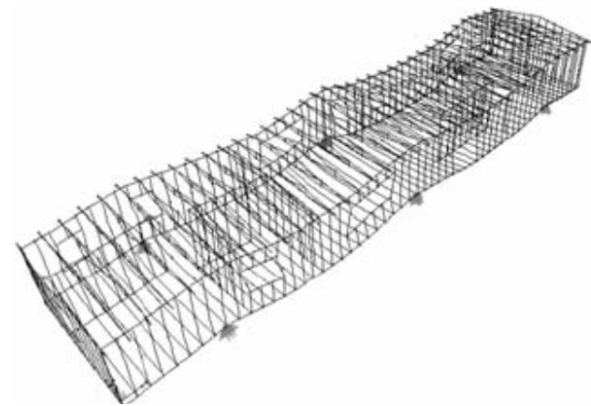
a. During lifting

The deformations predicted at various sensor locations are shown in Table 2 and typical predicted deformed shapes are shown in Fig. 3. Deformations from static load FE models were not entirely consistent with those measured during the field tests. This is attributed to inaccurate modeling of plasterboard to framing connections/interfaces. Ongoing work will include upgrading models in this respect and to incorporate failure criteria for initiation of damage directly to plasterboard linings. All the same, the models correctly indicate the vulnerable regions and components in prefabricated mini homes. We presume the same is true for prefabricated building modules. Although for the tested mini home acceleration/impact induced forces were not critical, FE models for these variables will be developed because such findings may not always hold true. The issue of coupled fluid (air) and structure interaction will also be investigated. When fully developed, the models will aid in the creation of

**Fig. 3** Deformed FE model of mini home
